Amt der Vorarlberger Landesregierung

Subject: Horse farm Dünser, Rankweil-wide Ried;  
Assembly / drainage of horse boxes and exercise areas;  
Proposal of the technical solution including evidence;  
References: Bills market town of Rankweil ZI: III-131/9-965/6, 18.Nov. 2004  
-11 - (4 photographic imagery)  
Attachments:

**Opinion inc proposal  
Gewässerschutztechnischen the official experts**

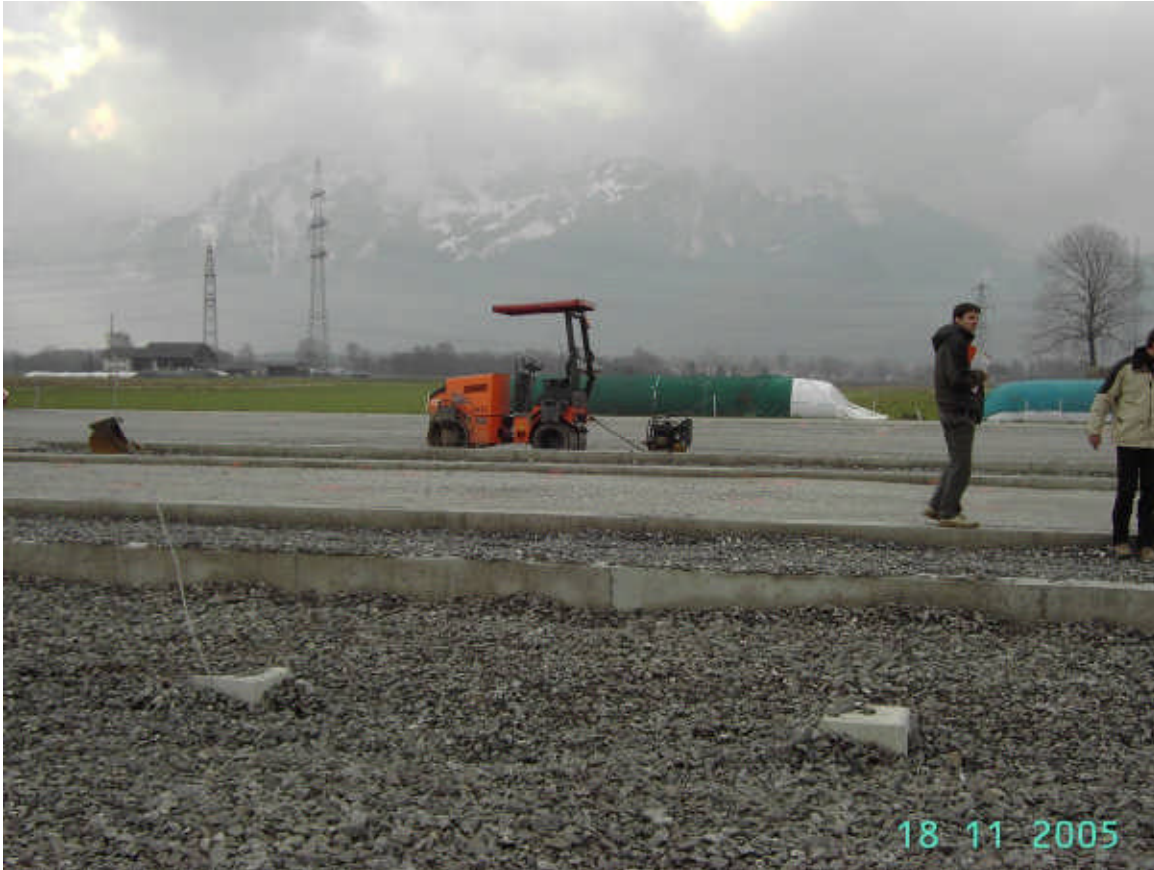
Photo 1: New Range Reithof Dünser, looking towards the west, as of 18.11.05

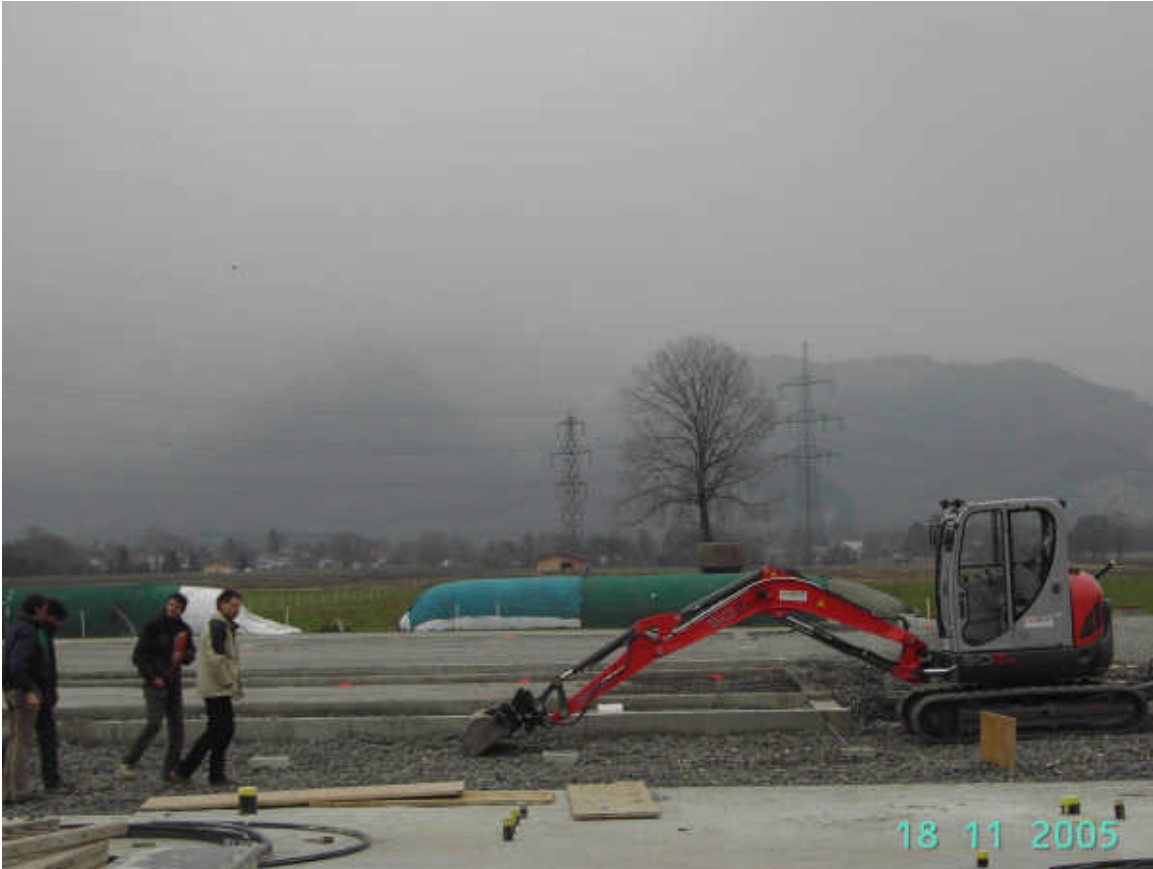
Photo 2: Detail Recording Reithof Dünser, looking towards the west, as of 18.11.05; Ummauerte areas behind excavator bucket seats are future boxing / Pedoks.

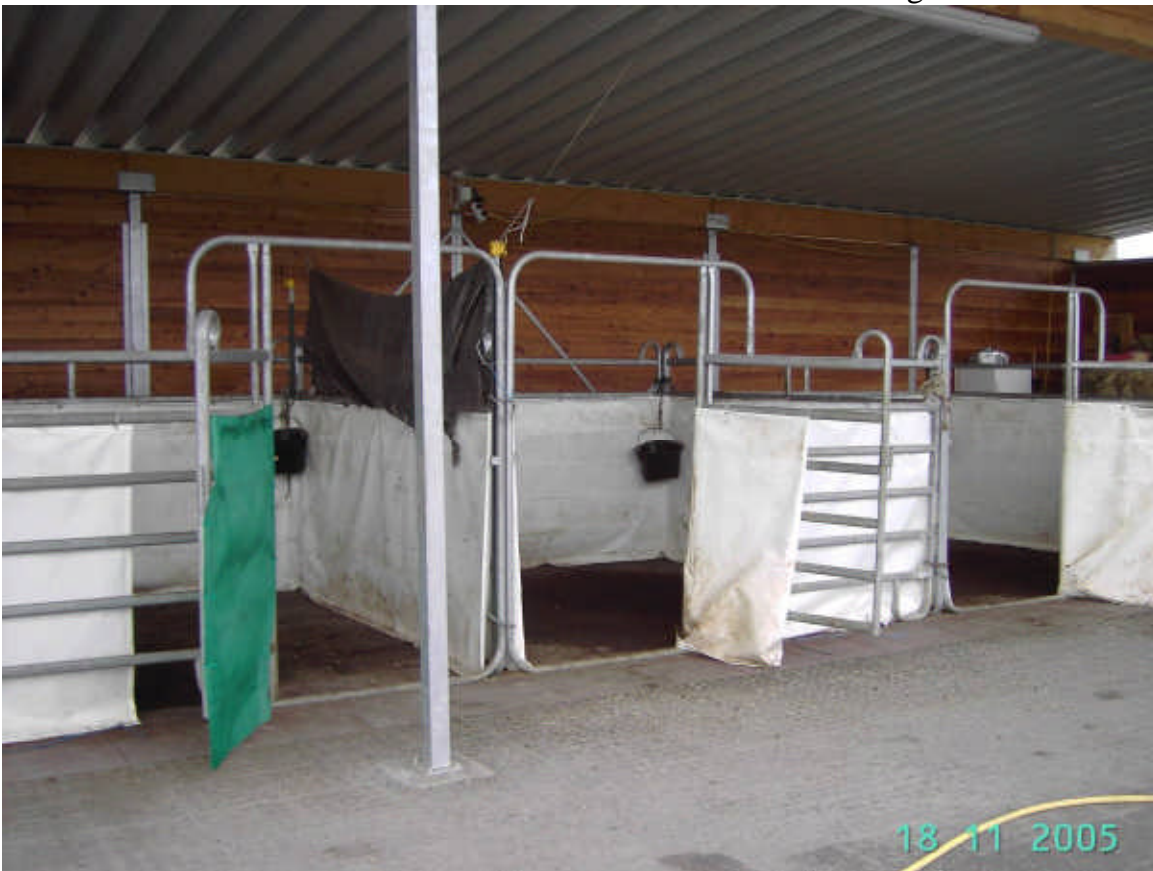
- Mr. Markus Dünser, operators
  - Mr. Christoph Loacker, Loacker sports and horticulture Ltd.
  - DI Guntram alga, WPA Ltd.
  - DI John Heinzle, WPA Ltd.
  - Employees of Loacker Ltd.
  - Dr Klaus King, Department of Water Management - VIId
- Based on the current investigation results of a test area (drainage / Dränierung of horse boxes in the eastern area, see also Report of the undersigned, 04.05.2005, photo or 3 supplements - examination certificates of Böhler Analysis Ltd.) can be assumed that the nitrogen content of leachate from horseboxes maximum (in the case of the roof) in the range of 120 mg / l.  
For further calculations it is assumed that a horse in the field of 10 l / day urine of itself.

Photo 3: Riding Stables Dünser, boxing eastern area forecourt, "experimental drainage"

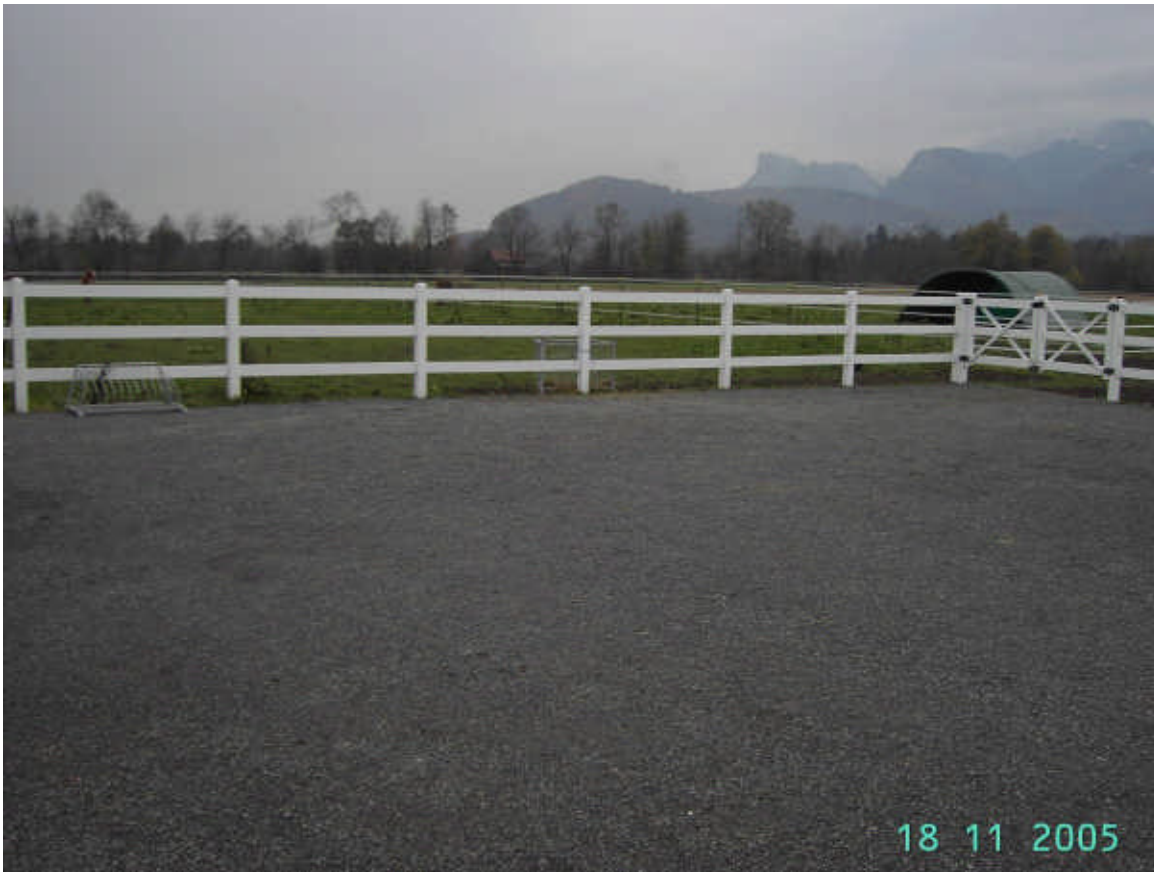
- After intensive research, despite a state of the art drainage halbdurchlässiger surfaces (such as when the system is "grass concrete Ecoraster", see photo 4) in the case of horses exercise areas does not exist, basically on the spot following approach as environmentally sensible, and it recommended:

Photo 4: Horseback riding Dünser "grass concrete Ecoraster" Clear tread eastern area (east of the pit / of forecourt according photo 3), peripheral drainage drainage if necessary; 18.11.05

- Common derive Dachwässern and freewheeling areas (surface waters, freewheeling areas covered by drainage, see photo 4) to a collection chamber, the Löschwasserteich upstream.
